Case Study: General Electric Corporation

- General Electric Corporate Headquarters
- Training Conference Center, Fairfield CT

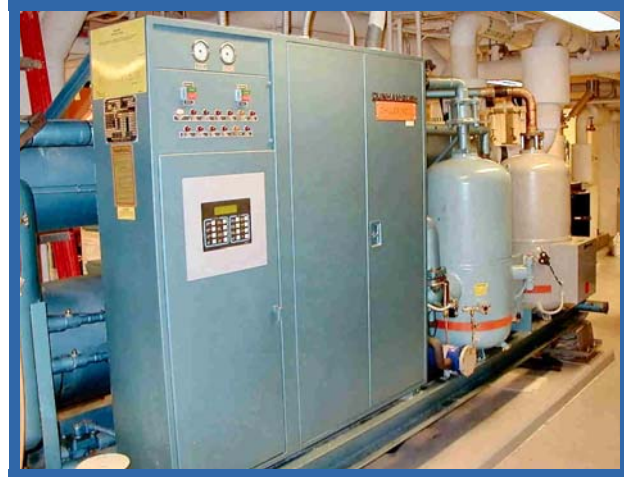
The upgrade was completed in July 2001. At start up, the MCS controller revealed the basic problem as low discharge superheat. Because the MCS controller monitors all critical areas, it saw that the discharge superheat was less than 5° F on both compressors and the discharge temperature was about 100° F. This low temperature resulted in oil migration from the compressors, causing repeated compressor shutdowns and failures.

Dunham-Bush Chiller with MCS Controls in a door mount application at G.E. Corporate Head Quarters.

Adjustments were made to the ball valves on the flash tank bringing the discharge temperature to approximately 130° F and the discharge superheat to approximately 25° F. These changes brought the oil that had migrated to the condensers back to the compressors. The excess oil in the compressors was then removed. The MCS controller also setup the compressors to rotate leads for more even wear and longer life.
