# **Micro Control Systems**

APP-013-B

## **Removal of Ferrite Bead on MCS-8, MCS-I/O, SI8, SI16 & RO8 Boards**

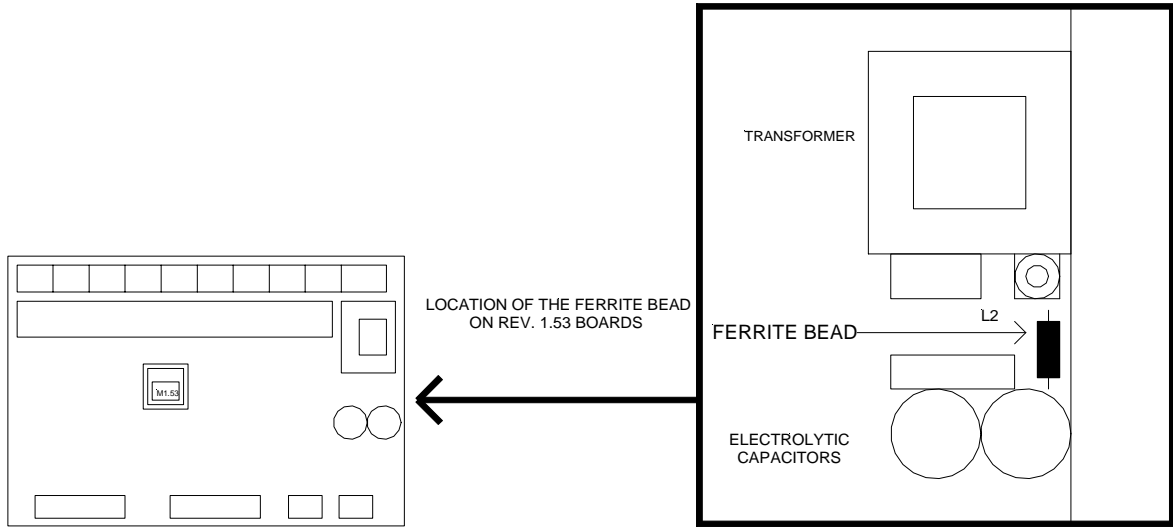
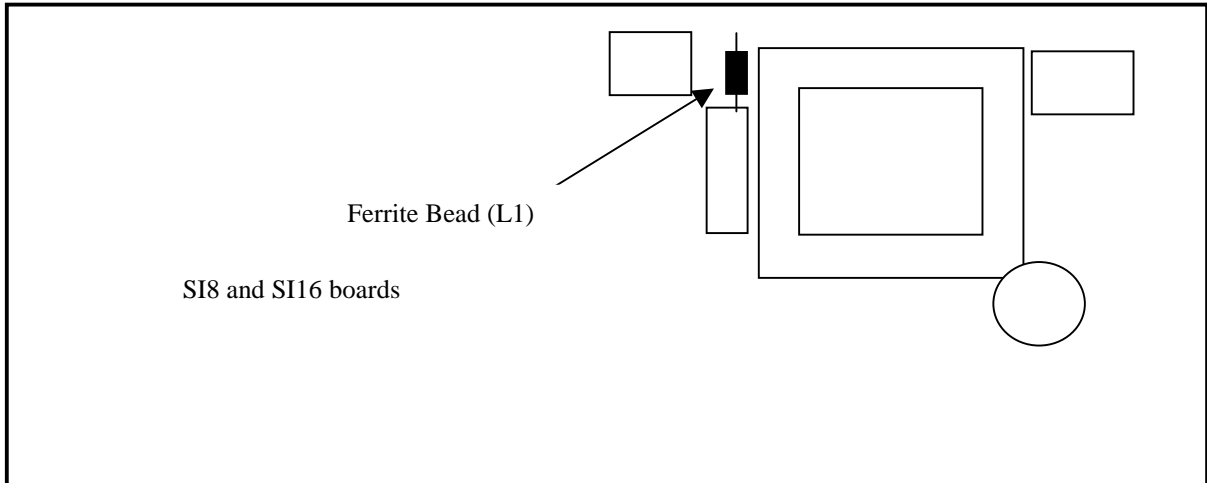
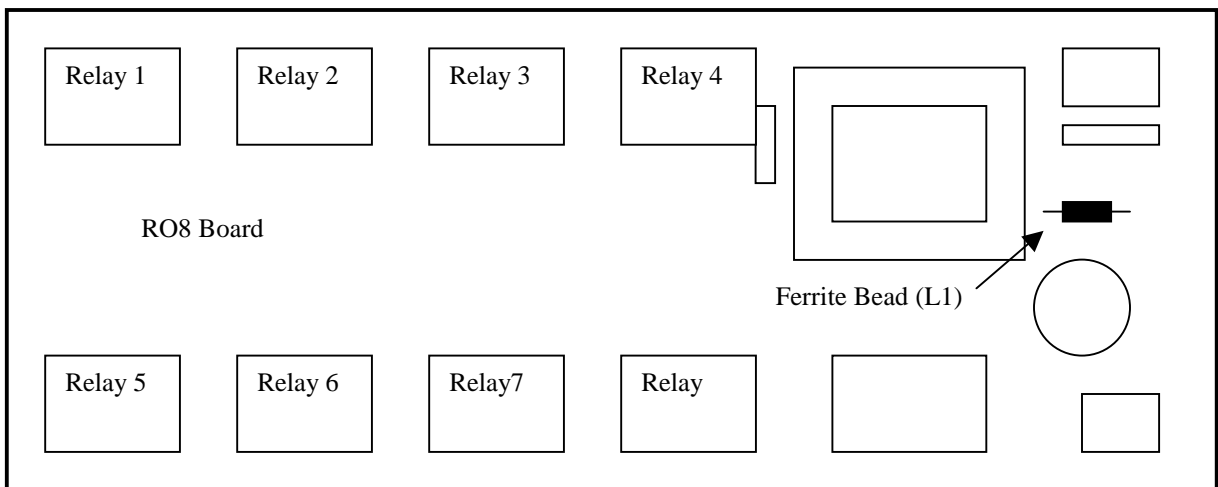
The purpose of this application note is to fix the problem of the ground planes having a different voltage potential than earth ground. Refer to the diagrams below when reading the procedure's steps.

- 1.) Turn power off to the unit and remove the board.
- 2.) To crush the ferrite bead, use lineman's pliers to grip entire width of the inductor and crush the ceramic dark gray material. This gray material is very brittle and will easily break away from the metal wire passing through it. Be careful not to break the wire passing through the bead.
- 3.) Brush away all of the loose gray material from the board, making sure there is no loose gray material around the other components.
- 4.) Finish by vacuuming on and around all of the components that are in the area of the inductor that was crushed.
