Micro Control Systems

APPLICATION NOTE

APP-025

Removal of the 1N5817 Diodes

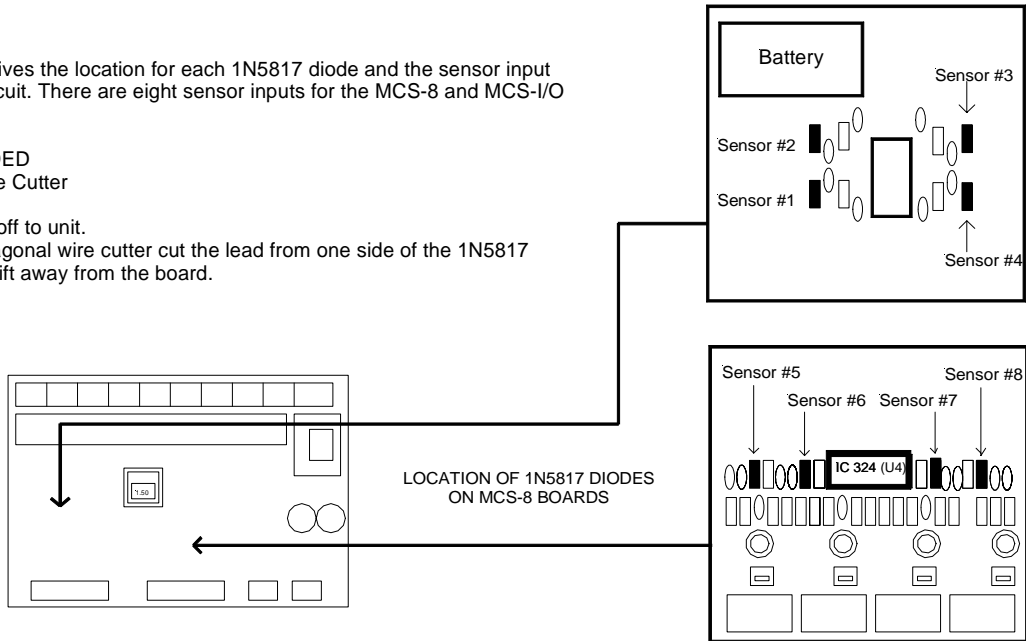
REMOVAL OF 1N5817 DIODES ON MCS-8 AND MCS-I/O REV. 1.50 thru 1.54 BOARDS

This drawing gives the location for each 1N5817 diode and the sensor input that is in its circuit. There are eight sensor inputs for the MCS-8 and MCS-I/O boards.

TOOLS NEEDED

* Diagonal Wire Cutter

1. Turn power off to unit.
2. With the diagonal wire cutter cut the lead from one side of the 1N5817 diode and lift away from the board.
