# Micro Control Systems APPLICATION NOTE

**APP-003**

## **Installation of Software and Config Chips**

This Application Note describes the installation of software and configuration chips on a MCS-8 micro-controller.

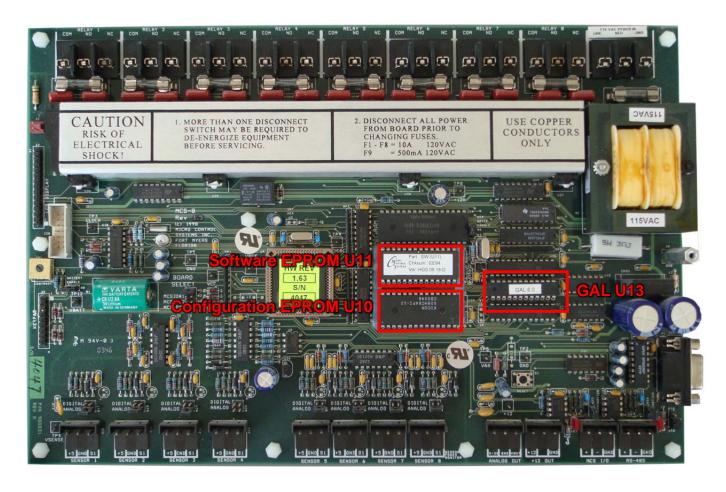
## **MCS-8 Chip Location Diagram**

- 1. Software Chip (EPROM) at location U11
- 2. GAL Chip (22V10) at location U13
- 3. Configuration Chip (E<sup>2</sup>PROM) at location U10

- 3. Now install the new chip.
  - Identify the correct chip for this location. Next to each socket and on each chip there is a location number, i.e., U11. Match the location number next to the socket with the location number on the chip.

- Note that the chip has a notch or dot at one end. Insert the chip into to the socket so this notch or dot is on the right hand side.
  - Take care to make sure all pins go into the socket. A pin can easily be bent under the chip or not inserted into the socket.
